Monitoring Data Record

Project Title: R-967CA (NC 24/27) COE Action ID: 200331135  
Stream Name: UT Big Meadow Creek (Site 1) DWQ Number: 030891  
City, County and other Location Information: Locust, Stanly County, NC 24/27 (Sta. 17+00 -L-)  
Date Construction Completed: 7-30-04 Monitoring Year: ( 3 ) of 5  
Ecoregion: \_\_\_\_\_ 8 digit HUC unit 03040105  
USGS Quad Name and Coordinates: \_\_\_\_\_

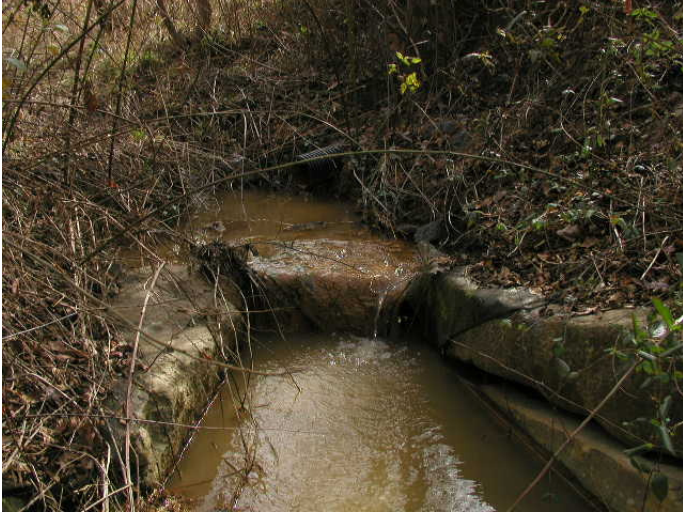
Photo Point #4 (Upstream)

UT to Big Meadow Creek is stabilized for the Year 3 winter evaluation, except for, a headcut at Sta. 16+40. This headcut looks to be caused by a drainage pipe coming onto the stream relocation just above the header rock on the crossvane (See Photo Point #4 Upstream Photo). Water was flowing overtop of this crossvane at the time of monitoring. There was also some bank scouring noted on the left bank @ Sta. 17+30 which is located upstream of PP#1. The bank scouring was noted during the last evaluation but looks stabilized now. NCDOT will continue to monitor this stream relocation for stability.

Date Inspected 1/20/10	Station Number 16+40 (PP#4 Upstream)	Station Number 17+30 (Additional Photo)	Station Number	Station Number	Station Number
Structure Type	Crossvane	Crossvane			
Is water piping through or around structure?					
Head cut or down cut present?	Headcut				
Bank or scour erosion present?		Minor bank scouring on left bank @ the end of the crossvane arm			
Other problems noted?

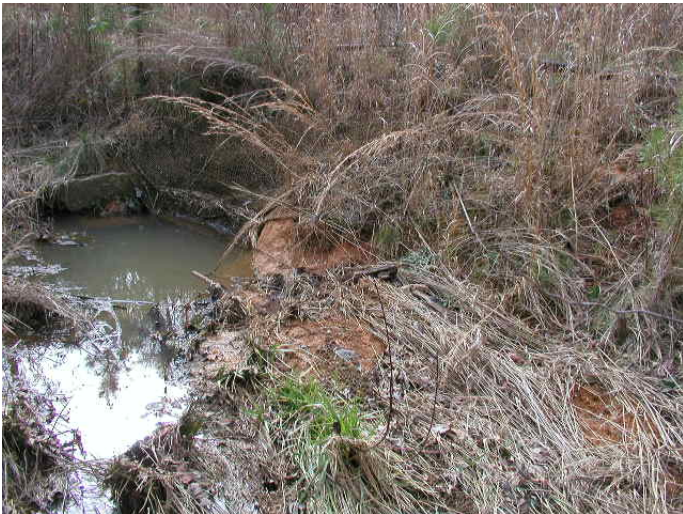
Bank scouring on left bank @ Sta. 17+30
